USACE KISSIMMEE RIVER RESTORATION C-38 REACH 3 BACKFILL AND BASS EMBANKMENT DEGRADE

CLIENT BCPeabody Construction

LOCATION Okeechobee & Highlands

DATE October 2015 – October

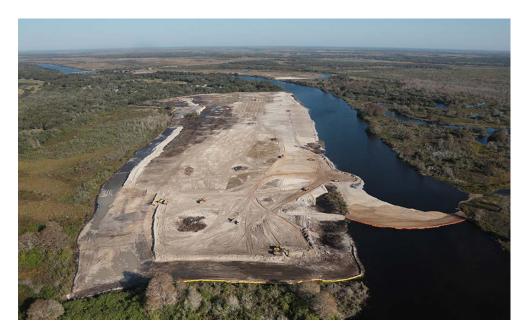
Beginning with the construction of the earthen plug at the southern section of the backfill to stop the flow of water though the C-38 canal. NorthStar then constructed additional intermediate plugs to re-route the water into the historic oxbows while containing all silts and turbidity on-site. The intermediate plugs zero out of the flow of water between plugs and reduce the amount of loss due to erosion and turbidity. Additionally this approach captures the silts that surge up from the existing bottom of canal encapsulating into small cells, which maintaining the bearing capacity of the backfill soils to allow the off-road dump trucks to operate efficiently.

The northern stockpile of soils is located on an island that is inaccessible to equipment. NorthStar designed and constructed a temporary floating bridge for access to the stockpile utilizing sectional barges to create the bridge that met the requirements of the USACE EM385-1-1 and OSHA. The bridge was designed to allow access for equipment, construction vehicles, fuel, and loaded off-road dump trucks hauling material. The floating bridge allows for water to continue to flow though the oxbow while allowing continual access for equipment.
