## SANFORD MGP SITE

CLIENT	Progress Energy
LOCATION	Sanford, FL
VALUE	\$14 M
DATE	July 2009 - September 2010
SΔEETV	Zero OSHA Recordables

## In-situ stabilization (ISS)

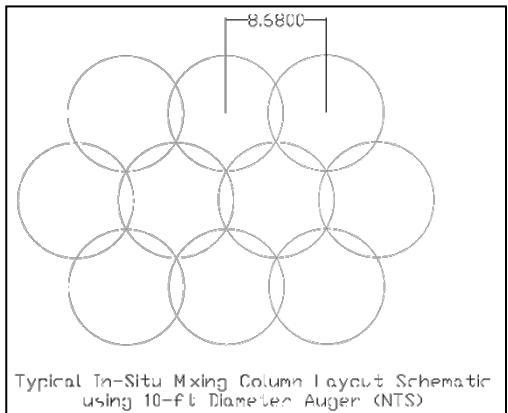
The DSM Treatment was performed in a series of overlapping columns as per the schematic to the right. Columns along the perimeter of the DSM area had a 1 foot overlap in the area known as the triple treatment triangle, while the interior columns will have a neat-line overlap.

NorthStar used a TOPCON 3000 Series Total Survey Station during DSM operations. This instrument insured the proper overlaps of the columns, the locations of the columns, the vertical extent of the treatment, and the rate of advancement of the tool. Using the predetermined column locations, NorthStar placed stakes at the center point of each column slated for treatment for the day's production.
